Manhole Inspection Summary

Manhole # S17I__016MH

Insp Date: **10/9/07 8:51 AM**

Location Address: **2 GORMAN ST**

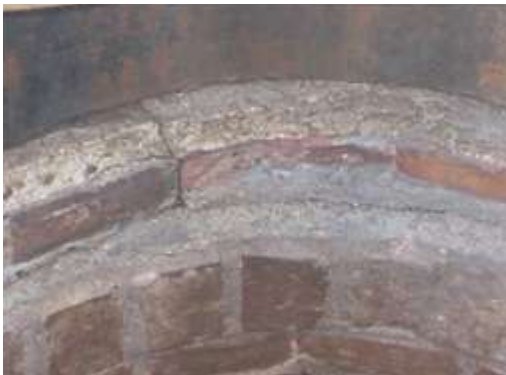
Defect 2

Chimney / Frame Adjustment ☒ Exists Material: **Brick and Concrete** ☐ Parged Height: **3** (in.)

Condition: ☐ Sound ☒ **Cracked** ☐ Root Intrusion ☐ Loose Brick ☐ Deteriorated

CRACKED CHIMNEY

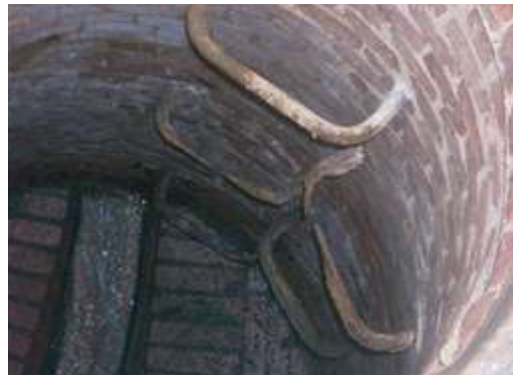
Defect 1

Steps Count: **4** Missing: **1** ☒ **Corroded**

MISSING AND CORRODED STEPS

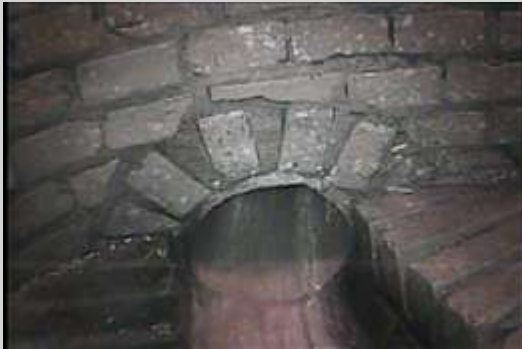
12 O'Clock Outflow

8 in. Circular Gravity Sewer
Pipe Out @ 12 O'Clock

Pipe Height: **8.4** (in.) Rod and Bar (Angled)
Pipe Material: **Clay** ☐ Pipe Lined
Invert Depth: **9.94** (ft.) Flow Characteristics: **Fast**
Deposits: ☒ None ☐ Mud ☐ Sludge ☐ Debris ☐ Grease
Silt Depth: (in.) Deposits Extent:
Infiltration: **None** Pipe Seal Cond: **Sound**

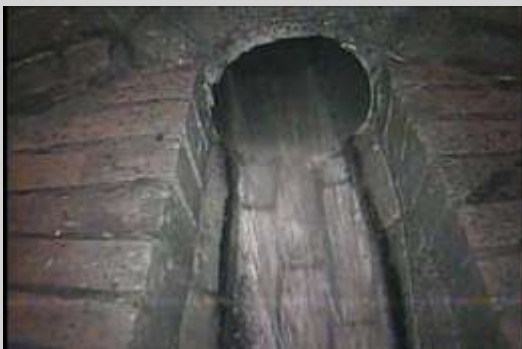
3 O'Clock Inflow

8 in. Circular Gravity Sewer
Pipe In @ 3 O'Clock

Pipe Height: **8.4** (in.) Rod and Bar (Angled)
Pipe Material: **Clay** ☐ Pipe Lined
Invert Depth: **9.36** (ft.) Flow Characteristics: **Fast**
Deposits: ☒ None ☐ Mud ☐ Sludge ☐ Debris ☐ Grease
Silt Depth: (in.) Deposits Extent:
Infiltration: **None** Pipe Seal Cond: **Sound**
